AquaBlok®

Installation Summary

Objective: Dam Construction & Pond Rehabilitation

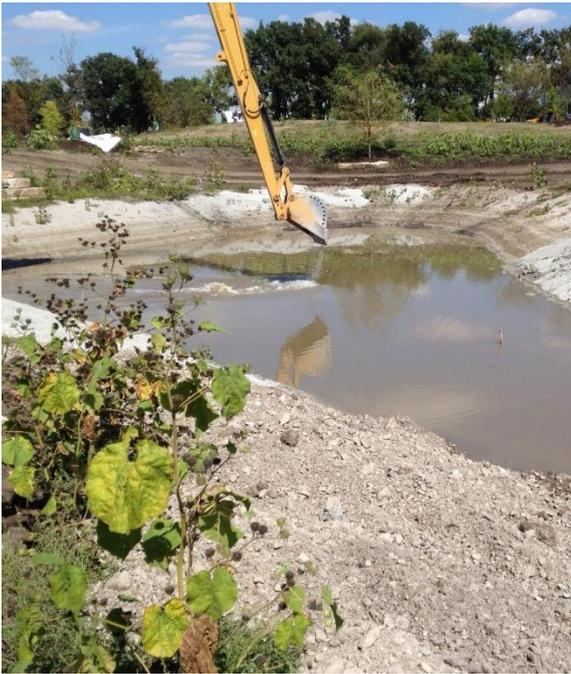
Photo 1: Uniform distribution of AquaBlok 2080FW directly through the water using an excavator.

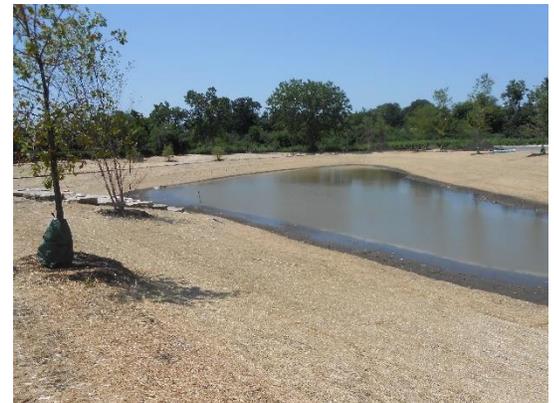
Photo 2: First pond after installation.

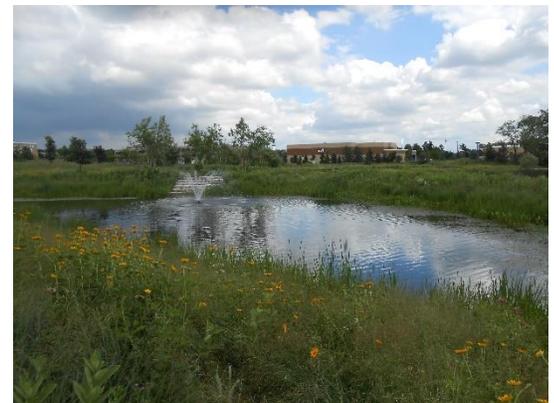
Photo 3: After AquaBlok installation and growth of vegetation.

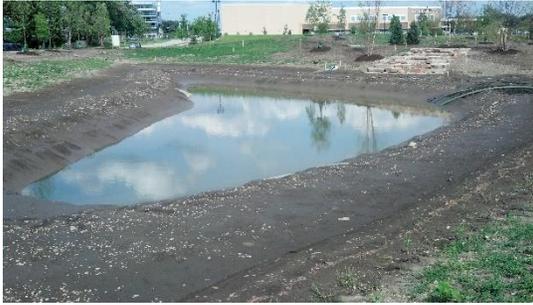
Photo 4: Pond prior to AquaBlok installation.

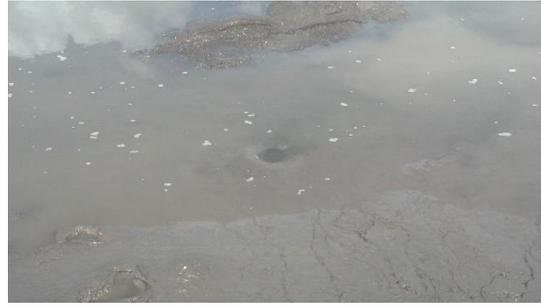
Photo 5: A 2ft-deep spring in the bottom of the second pond.

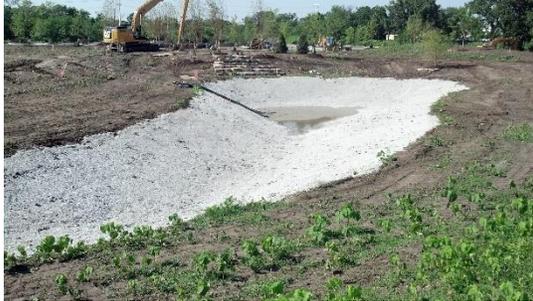
Photo 6: Pond uniformly lined with AquaBlok 2080FW.

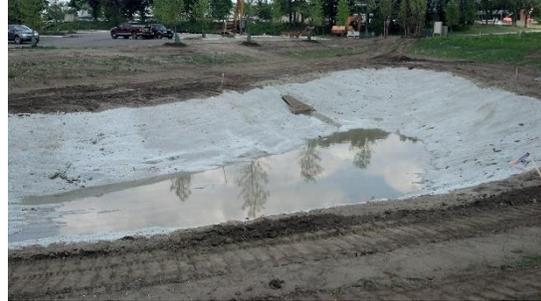
Photo 7: Pond uniformly lined with AquaBlok 2080FW. Pond is starting to fill.

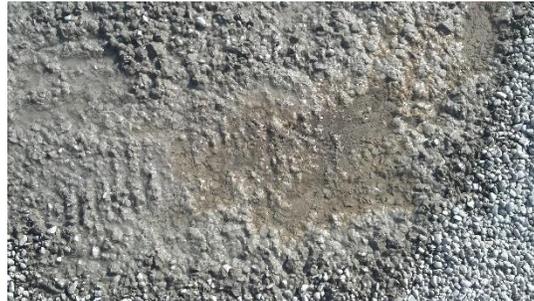
Photo 8: Up-close image of AquaBlok 2080FW immediately after installation. Here, the material is just starting to hydrate and swell. Note the dry material in the bottom right corner.
