REPAIRS > SYNTHETIC LINER REPAIR

WATERFORD TOWNHOMES POND HDPE LINER REPAIR

ROCHESTER, MN (COMPLETED JUNE 2009)

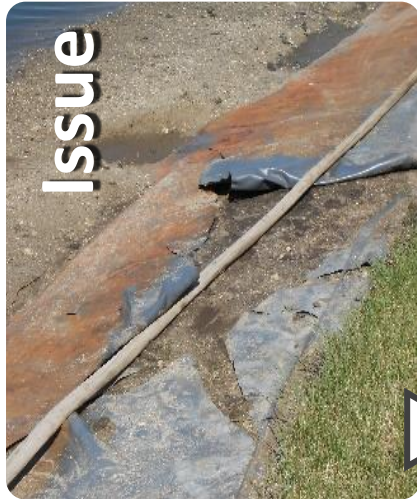
Issue

When the Waterford Townhomes Development was built in 1994, a High Density Polyethylene (HDPE) liner was installed to create a 2.6-acre stormwater pond. The HDPE liner kept the pond at a constant level for 15 years. But in 2009, leaks in the liner started causing gradual water loss. Cover soil placed above the liner had washed away, and UV degradation of the HDPE resulted in rip and tears of the liner. Welded repairs were ruled out because of the age and condition of the liner, and clay capping was deemed too expensive, with issues preventing

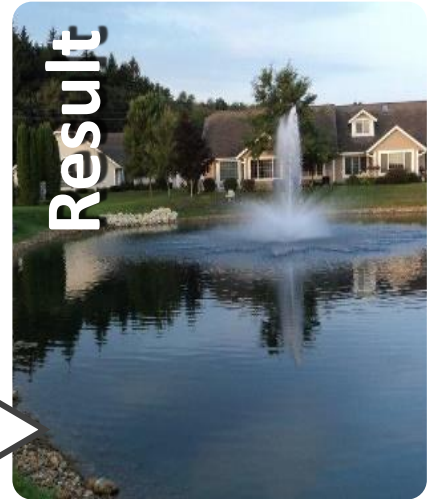
Result

placement. AquaBlok was chosen to seal and stop leaks, and cover and protect the liner from additional damage. AquaBlok was placed atop the existing liner along the bank using small equipment with minimal disturbance. Over 10,000 lineal feet of shoreline was covered with AquaBlok in just a few days, saving substantial time and costs versus other solutions. Ultimately, AquaBlok was partially covered with rock riprap to complete the shoreline restoration and save the pond.
