SEEPAGE CONTROL > DAM/LEVEE ENHANCEMENT

# SHUGERT LANE DAM REPAIR

LORE CITY, OH (COMPLETED MAY 2019)

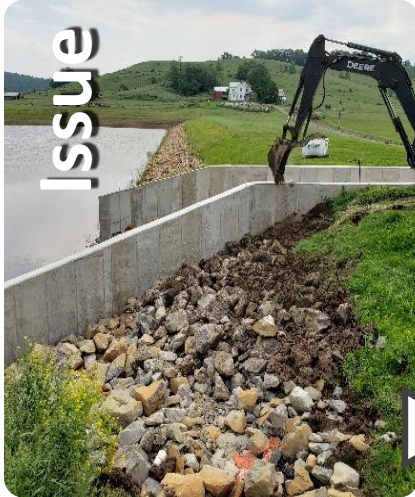
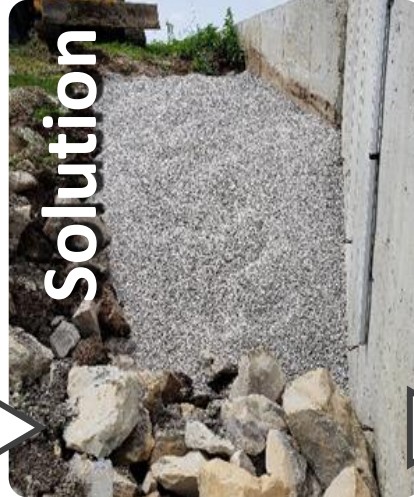
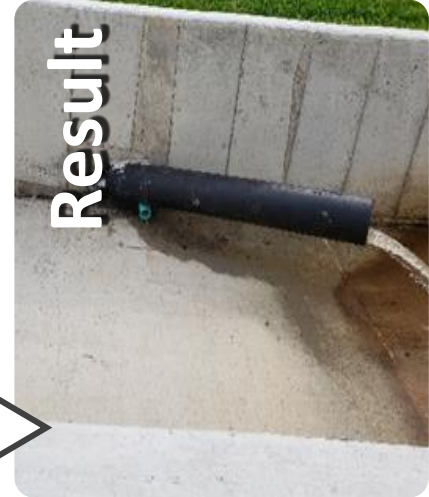
Owners of the Shugert Farm learned after constructing a multi-million-dollar farm pond that their dam was in jeopardy of leaking substantial amounts of water from an underdrain pipe adjacent to the spillway wall. Removal of the spillway wall or parts of the dam's embankment material was risky, but there were very few other options available for this type of repair. Fortunately, the owners discovered AquaBlok as a sustainable engineered solution to seal the underdrain and preserve the spillway wall. After excavating

and exposing the underdrain, the contractor was also able to place AquaBlok in a constrained area that would have presented major challenges to that of conventional compacted backfill. After covering with a geotextile fabric and a combination of topsoil and rock riprap, the AquaBlok hydrated and swelled to create an impervious, durable seal over the leaky underdrain. The procedure was repeated on the other side of the spillway, and water loss was stopped through the dam.
