# Liner Repair

## Using an Engineered Bentonite/Aggregate Composite

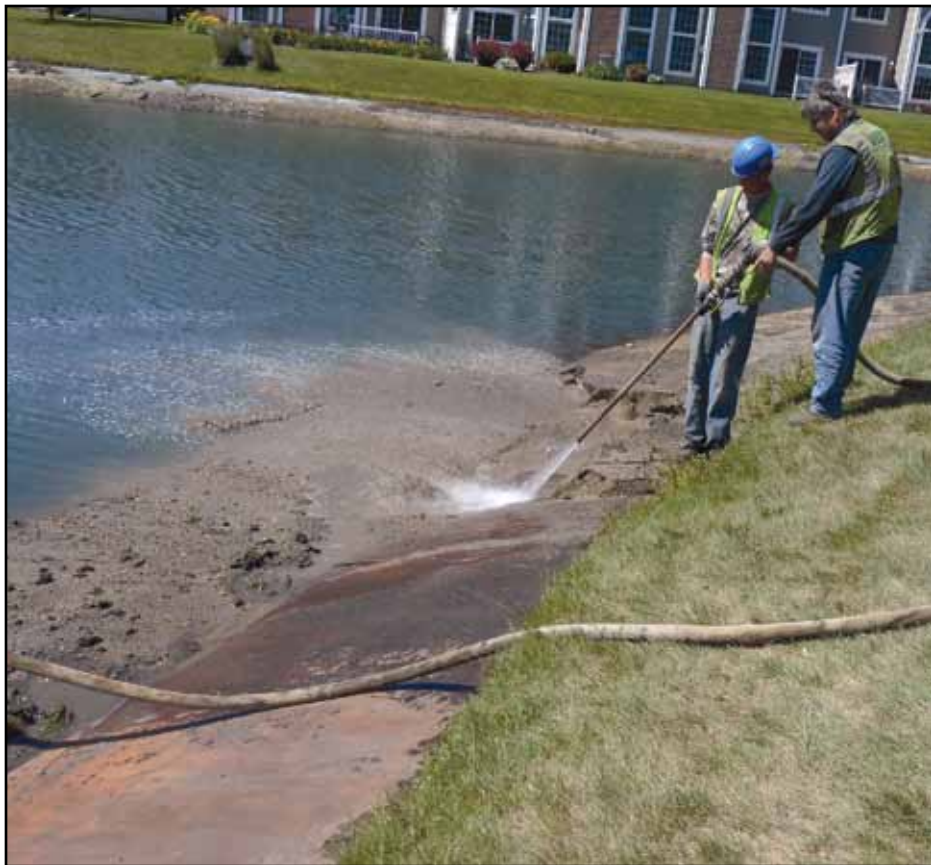
**Contractor removing up to 12-inches of cover sand/soil atop the compromised HDPE liner using a power washer at moderate pressure.**

pumps and power washers (at moderate pressure) to displace the remaining cover material on the upper five feet of the basin's shoreline slope. They had two operators, each with their own equipment, to expedite the process. Although somewhat time consuming, the method was very effective in cleaning off the cover material and in revealing all the damaged areas that needed to be treated.

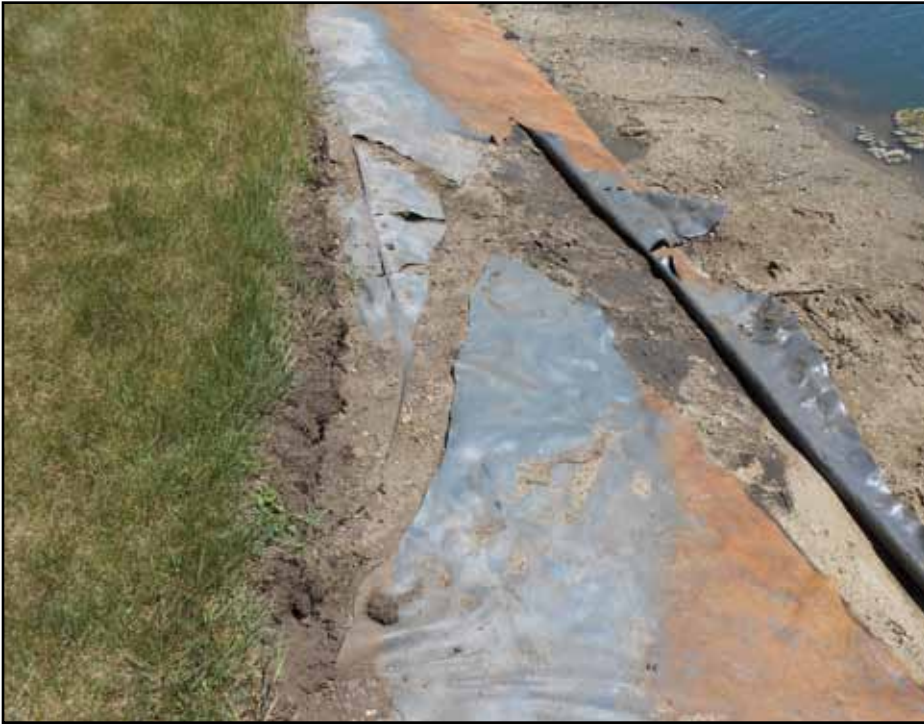
**A typical cut in the HDPE liner impacting an approximately 2' x 6' area of the basin's shoreline edge - probably caused by a combination of UV exposure, ice damage, and age.**

In 2009 the Townhome Association noticed that the lake was no longer maintaining its designed level. Even after being filled by snow melt and rain fall events it took just a few days for the lake to drop below its desired level. With leaking lakes or ponds just finding the source of the leak can present a herculean challenge. Fortunately that was not the case with this project. With some careful inspection, homeowners discovered that over the years the cover material (~12-inches of sand and gravel) on sections of the upper slopes of the liner had washed away, leaving it exposed to the ultra violet rays of the sun and increased stress from ice and even from simple foot traffic. While known for UV resistance (even without cover), HDPE – like any synthetic geomembrane – has its vulnerabilities and life expectancy. Inherent lack of flexibility can cause brittleness in the material and, especially when exposed to the elements (e.g. shifting ice), problems can develop. These forces combined to cause damage to the liner at Waterford. They resulted in tears and holes ranging in size from three inches to five feet. As water crested compromised portions of the liner, it could now easily seep down into the sandy soil.

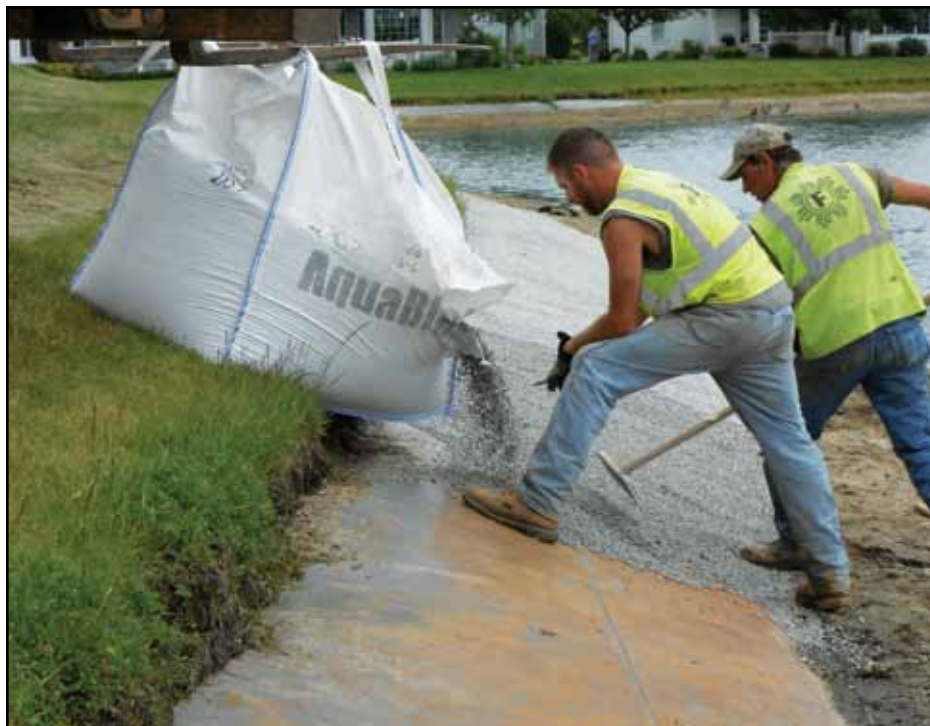
**Placement of the bentonite/aggregate composite directly out of a shipping tote (note suspension of the bulk super sack on a long-reach forklift).**

than three total truckloads) of the bentonite/aggregate composite completed the sealing job. The material was applied at a targeted 1.5-inch material thickness (~10 lbs per square foot) by direct placement from its shipping unit (packaged in a super sack or bulk tote). It was raked by hand to ensure uniform coverage.
