POND SEALING > POND LINING, SEALING, CAPPING/CLOSURE

RAREY RESIDENTIAL POND SEALING

FINDLAY, OH [COMPLETED OCTOBER 2009]

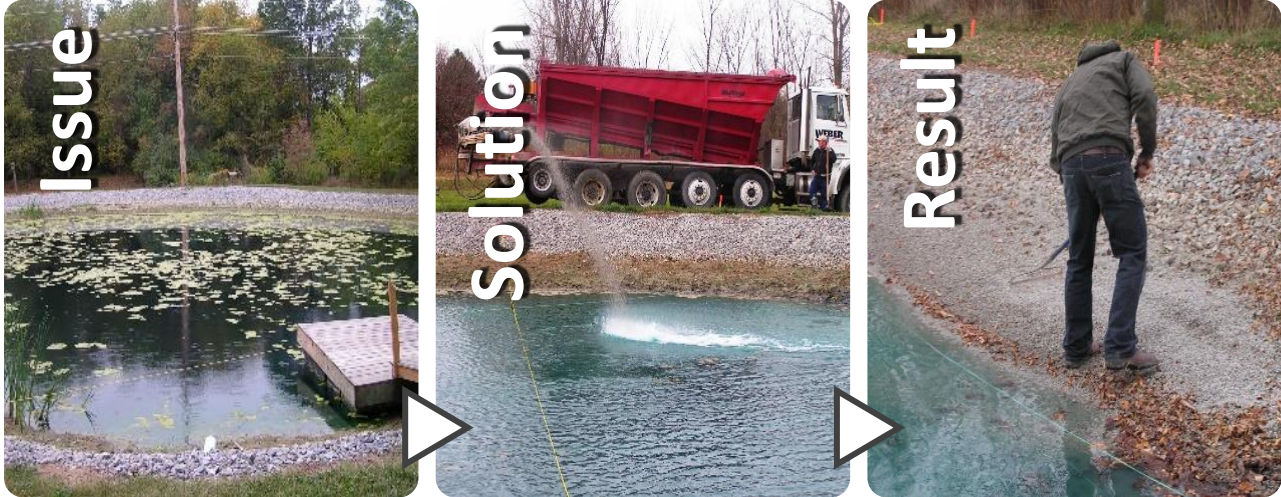
The Rarey family of Findlay OH, loved their backyard swimming and fishing hole, originally constructed with a compacted clay liner to retain water. Over the years, silt and sediment began to build up in the pond, making it shallower and messier until the Rarey's decided to "de-muck" the pond to return to its original beauty. Yet the de-mucking operation went deeper than originally planned, and portions of the clay liner were unintentionally excavated and removed. The cost and logistics

of a full clay liner replacement were not feasible, so AquaBlok was presented as an alternative method for repair. Without having to drain the pond, 40 tons of AquaBlok was placed over 11,400 square feet of basin bottom and side slopes to repair the excavated clay liner. The AquaBlok application was performed using a remote-controlled stone slinger from the shoreline and completed within a few hours. The repaired pond was filled and ready to use again right away.
