# AquaBlok®

## Installation Summary

### Objective: Trench Dam

Location: Morgan City, LA

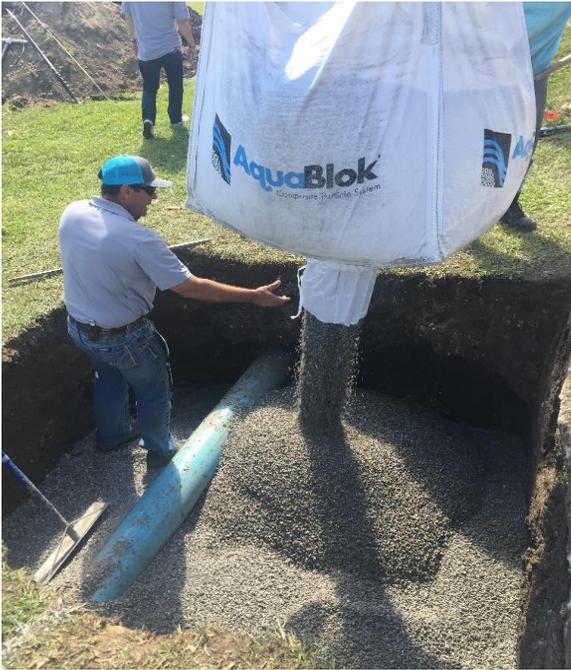
Photo 1: Placement of AquaBlok from a bulk bag.

**AquaBlok Solution:** 46 tons (9 truckloads) of AquaBlok were shipped to the project site in 2,400lb bulk bags to be used in the trench dams. To address the four gaps that formed at the pipe joints, wire mesh and stainless-steel screens were used first and then covered with a geotextile fabric. Material was then simply poured around the pipe and into the trench using a forklift. Because AquaBlok self-seals when hydrated, no mechanical compaction was needed. The contractor utilized the funnel spout on the bottom surface of the bulk bag to direct the AquaBlok into the trench.

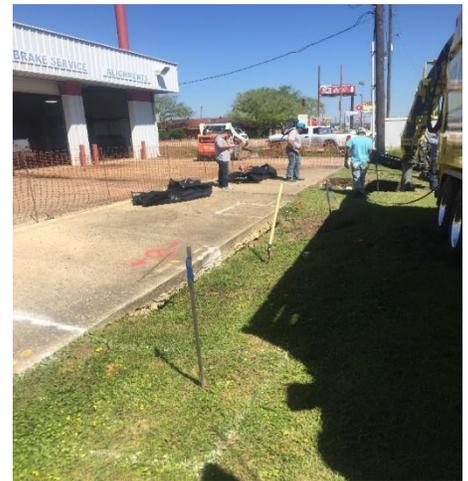
Photo 2: Subsidence along the foundation due to fines being pulled away at gaps between culvert joints.

**Background:** The site is currently being used as an automobile service station. A 60" drainage culvert running parallel alongside the concrete slab had been separated at 4 joints. Over time, sections of pipe began to subside, leaving gaps at the joints, which allowed storm water to pull fines away from the exterior of the pipe and deposit them downstream. This led to gradual subsidence of the soil alongside the concrete slab used for servicing vehicles.

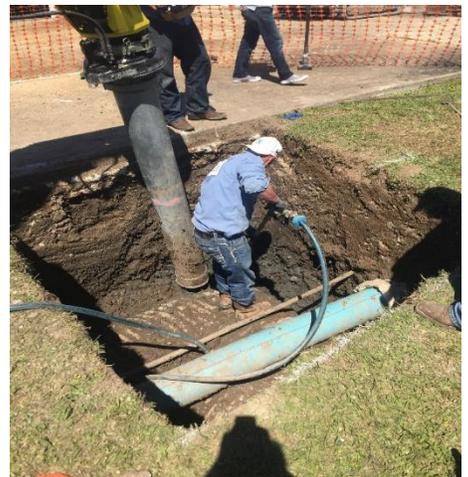
Photo 3: Trench being suction excavated due to existing water line and fiber optics present along exterior of culvert

**Technical Challenges:** Due to the location of the culvert and its proximity to the active service station, along with other utilities present in the subsurface, removal of the culvert was going to be cost-prohibitive and inefficient. In addition to an 8" water line that was installed within feet of the culvert, a sleeve of fiber optic cables had also been recently installed. In order to excavate the trenches without disrupting the functioning utilities in place, a suction excavator was used to remove the existing soil, allowing for uniform placement of material around the problematic areas. Conventional trench dams have been constructed using a variety of local materials, including soils. However, installation using soils require compaction to obtain low-permeability and is, therefore, time-consuming and technically problematic. Achieving uniform compaction of the soil around the trench dam can also create safety issues.

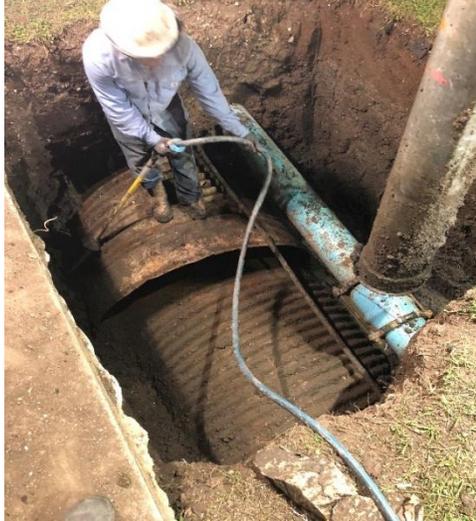
*Photo 5: Failure at culvert joint.*

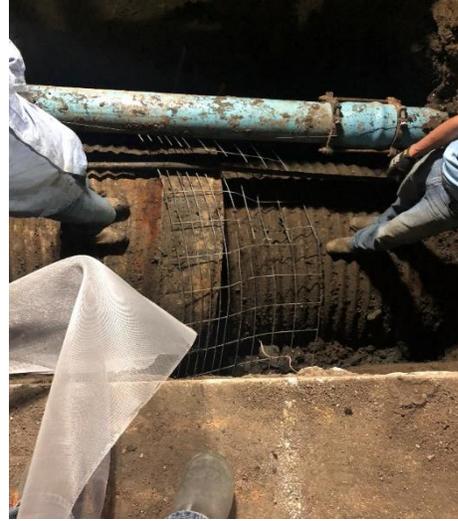
*Photo 5: Wire being formed over the approximately 12" gap along one of the joints. The wire was then covered with stainless steel screen and geotextile fabric.*

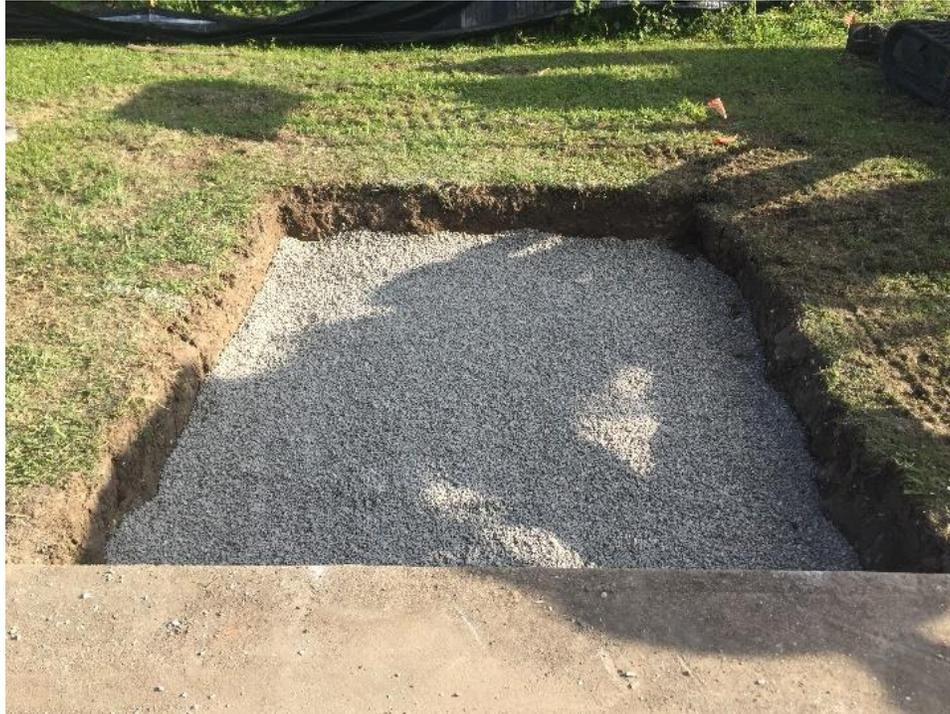
*Photo 6: Construction completed after filling trench with AquaBlok.*

**Timeline:** Once excavated, the AquaBlok trench dams were constructed in less than 10 minutes. The most time-consuming component was the pickup and transport of bulk bags from the trailer to the trench. Each bulk bag was emptied in less than one minute with controlled flow.
