CASE STUDY

Volume 1, Number 5

TRENCH DAM INSTALLATION STABILIZES BACKFILL ALONG PIPELINE AT WORCESTER, MA REGIONAL AIRPORT

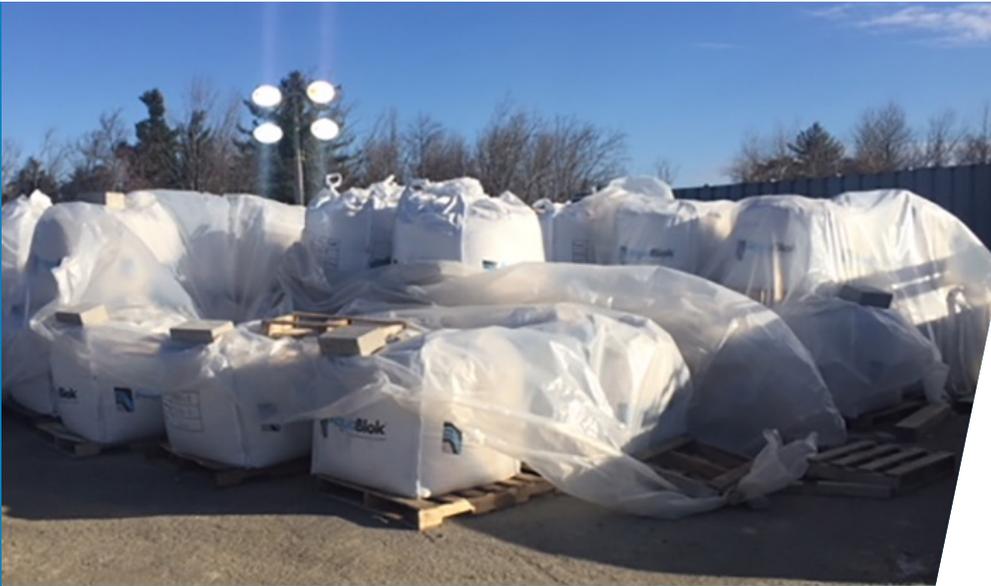
- Use AquaBlok® to create a watertight barrier at each trench dam location.

Metal plates encased the product installation. Each check dam consumed six cubic yards of material. Sometimes known as nature’s duct tape, the bentonite coated aggregate is widely used in applications where water flow prevention is required. Leaky pond bottoms provide another very common use for the product.
